**Re: Fire Department Building Safety Walkthrough Conducted on June 4, 2018**

### **The City of Mayer Fire Department: 400 Ash Ave N. Mayer, MN 55360**

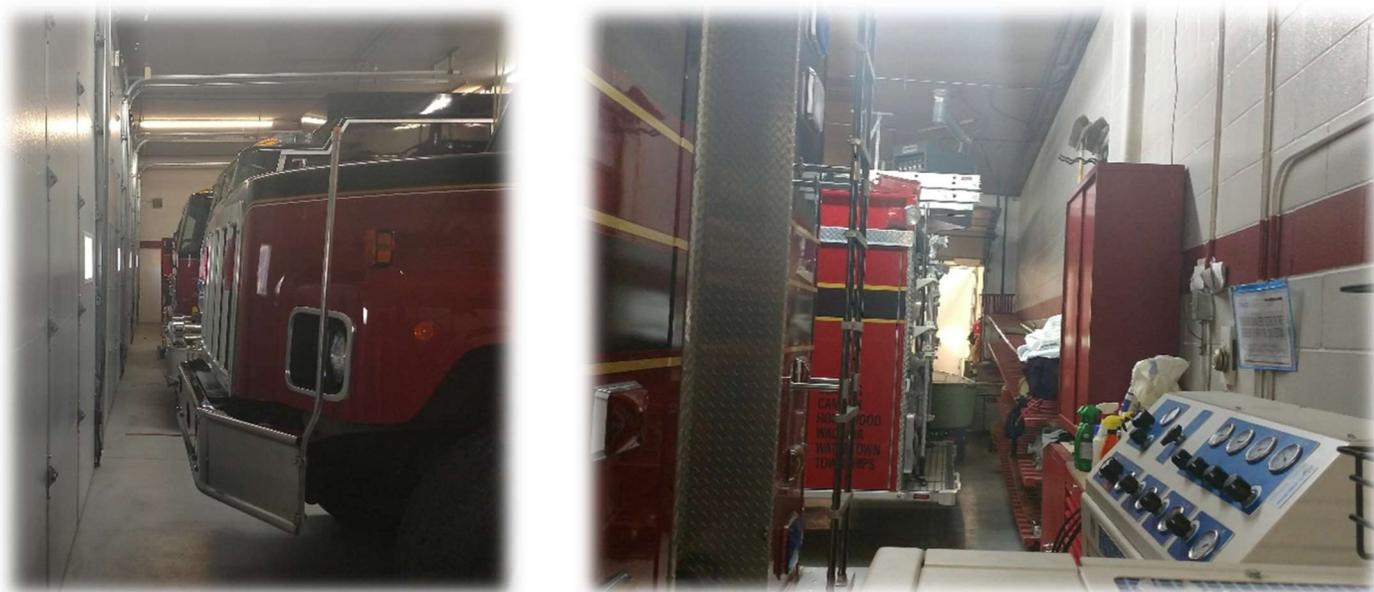
- Apparatus floor markings help ensure proper location of apparatus to maximize access, and limit hazards. Even with these parking markings, there is limited access at the front and rear of most apparatus for members to walk around apparatus. According to the [Safety and Health Considerations for the Design of Fire and EMS Stations](#) published by the US Fire Administration: Page 67 – A minimum 4-foot clearance shall be maintained (designated) around apparatus parked within the station. Most of the current apparatus do have a 4-foot clearance between. The Front & Rear of almost all apparatus does not meet a 4-foot clearance, with a few less than 2-feet.

(Front & Rear Apparatus, Less than 3-Foot Clearance)

**01-06/18: Recommend reviewing apparatus bays for access and clearance.** The Mayer Fire Department has a very well kept and organized facility including their apparatus bays. All bays have been filled with apparatus, as well as gear lockers, maintenance equipment, and some fire equipment storage.

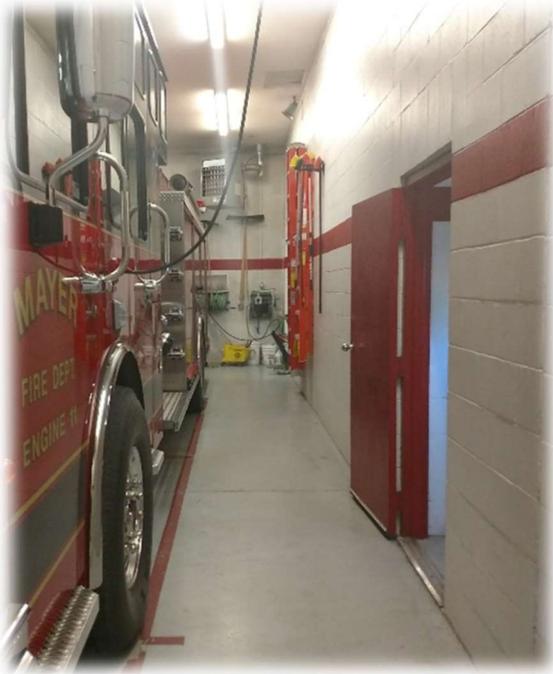
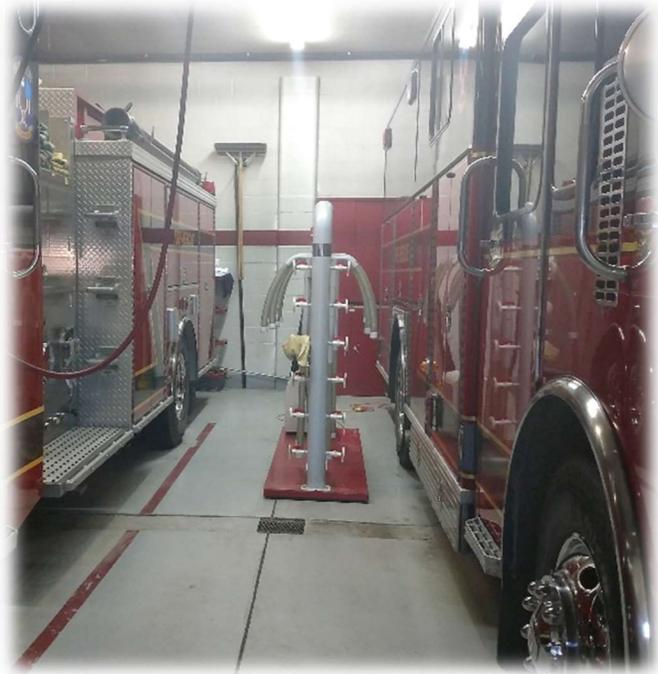
(Between Apparatus, most have 4-foot Clearance but also have multiple obstructions)

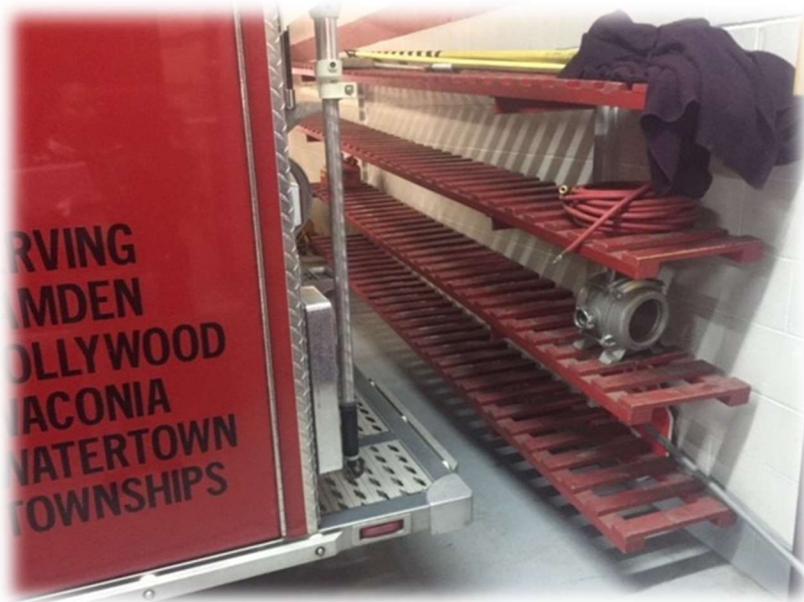
(Left Pic: Rear of Apparatus at the Hose Drying Rack, less than 2-feet of clearance)  
(Right Pic: All Apparatus have overhead Electrical Plugs to reduce clearance infringement)

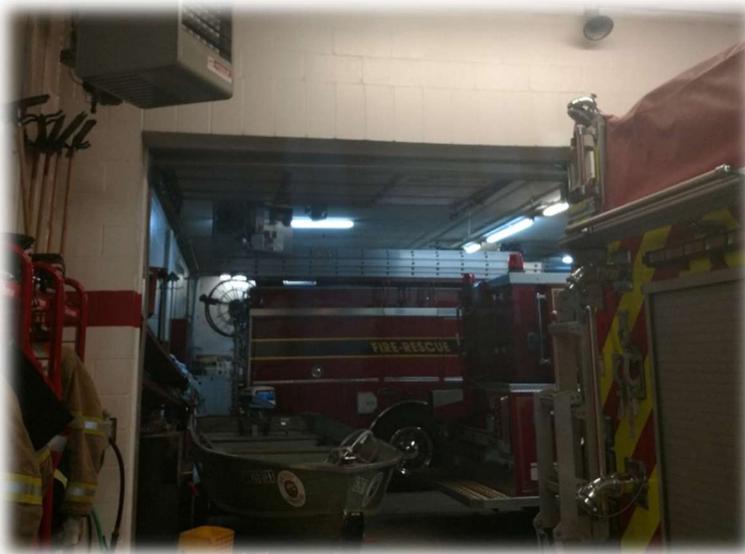
(Left Pic: Space for Boat, the Engine must be moved to get the boat out of the station)  
(Right Pic: Space between the boat and the Hose Drying Rack is limited)

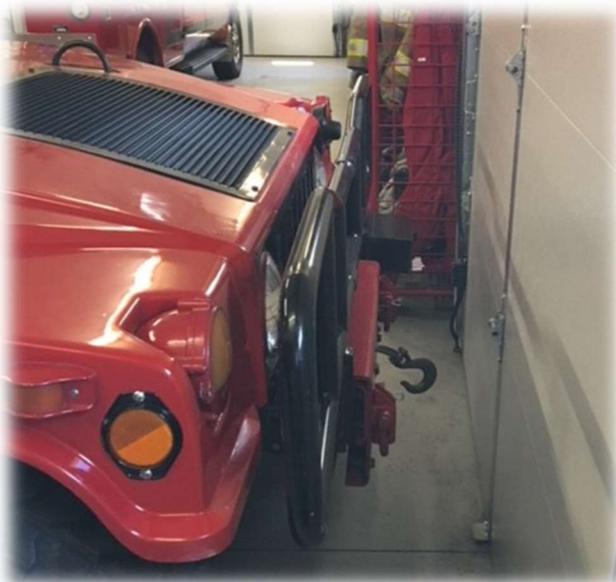
(Left Pic: The Grass Truck Clearance is less than 1-foot to the apparatus door)  
(Right Pic: The Gear Washing Area and Sink are blocked with additional equipment & items)

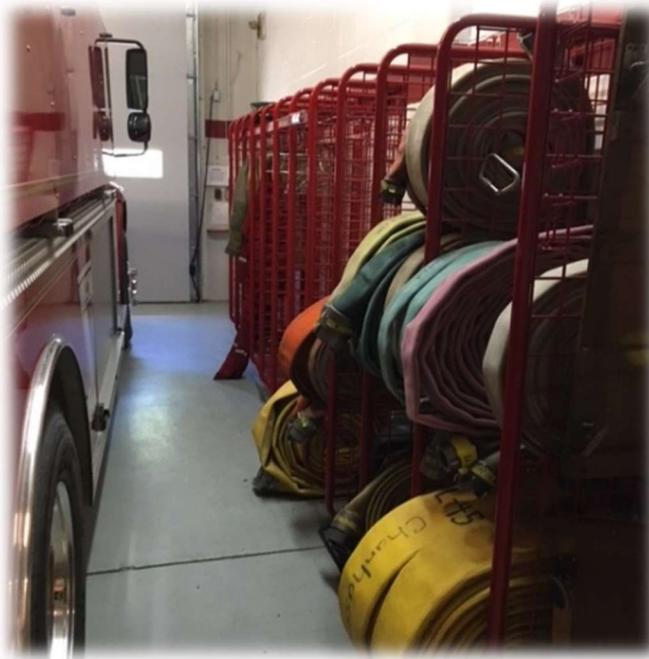
(Left Pic: The extra hose is stored in gear lockers, limiting space between trucks and lockers)  
(Right Pic: The trash receptacle impedes on the mezzanine staircase clearance)

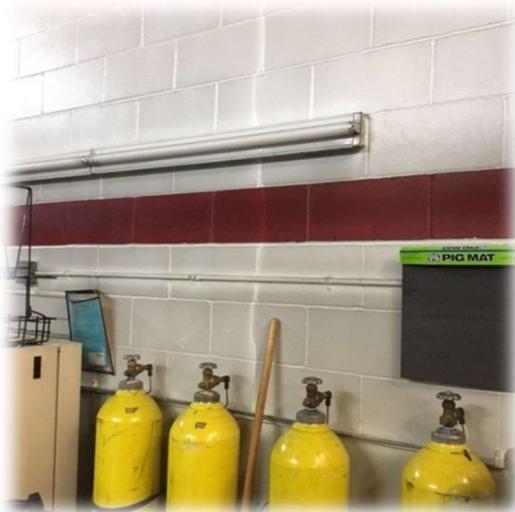
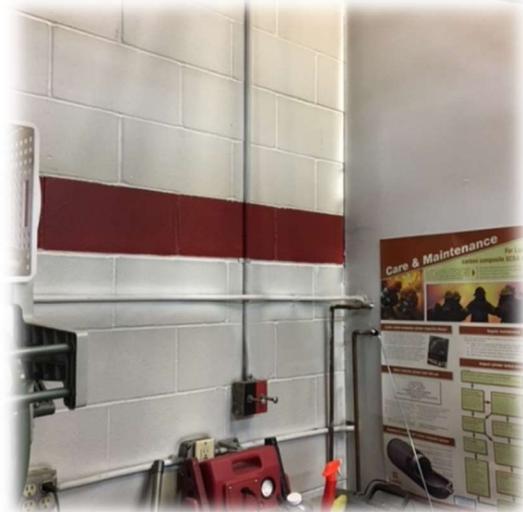
- Note: In the photos the discoloration of the white walls with diesel exhaust soot.

- Note: There has been a rising risk of Cancer within the Fire Service, and some of these concerns to reducing the risk of cancers in firefighters is the exhaust within the fire station. There are many changes in the fire service to prevent and reduce cancer in firefighters, and reducing the risk of exhaust exposure is one of them. [Diesel Exhaust & Other Carcinogens \(www.fccancer.org\)](http://www.fccancer.org)
- According to the [Safety and Health Considerations for the Design of Fire and EMS Stations](#) published by the US Fire Administration: Page 95 - Diesel exhaust has been classified as carcinogenic to humans by the International Agency for Research on Cancer (IARC), a branch of the World Health Organization.

**02-06/18: Recommend reviewing the Apparatus Bays and Exhaust Ventilation.** The Apparatus Bays are required to have a ventilation system for remove exhaust from apparatus. Minnesota State Statute **5205.0200 GARAGE VENTILATION**. Ventilation shall be provided for all repair garages, service stations, body shops, and all live storage garages, housing six or more vehicles driven by internal combustion engines. A live storage area is any area within a building used for the storage of fire trucks, tractors, automobiles, trucks, and other self-propelled vehicles driven in and out under their own power. <https://www.revisor.mn.gov/rules/?id=5205.0200>

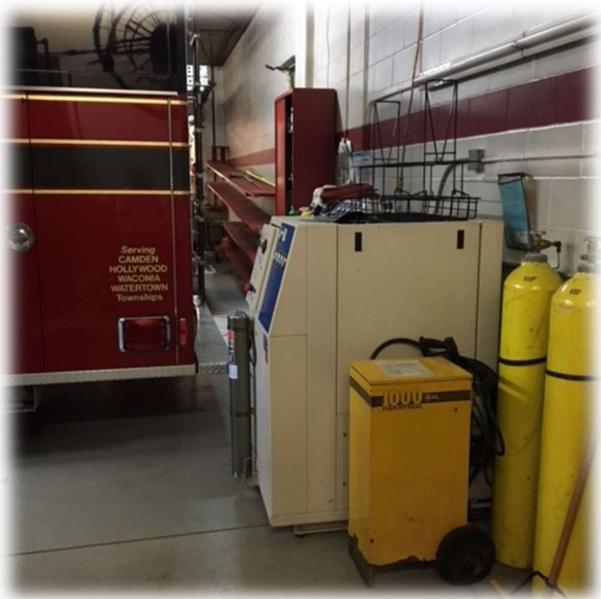
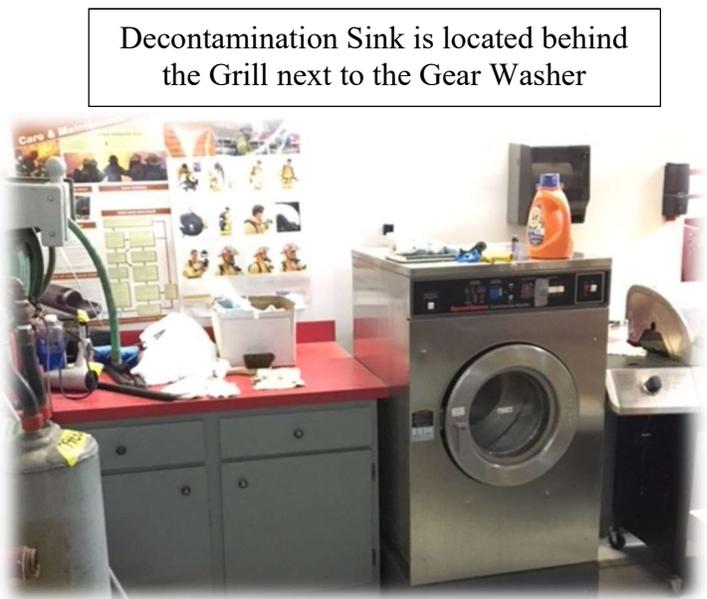
**03-06/18: Recommend reviewing the SCBA filling area.** The SCBA Filling station is currently in the apparatus bay and close to the sink for SCBA Decontamination. When firefighters return from training and/or fire's they must decontaminate their SCBA's, refill bottles, and inspect them for service. This is being accomplished in a limited space area.

- During the walkthrough Chief Maetzold discussed during warmer weather apparatus can be placed outside when these tasks are completed, but during freezing temps this task becomes more difficult because of space.
- The SCBA Fill station has been plumbed for Fresh Air from the exterior of the building, when filling SCBA's.
- The National Fire Protection Association (NFPA) 1852, *Standard on Selection, Care, and Maintenance of Open-Circuit Self-Contained Breathing Apparatus (SCBA)*, provides requirements for the inspection, testing and repair of SCBA.

Decontamination Sink is located behind the Grill next to the Gear Washer

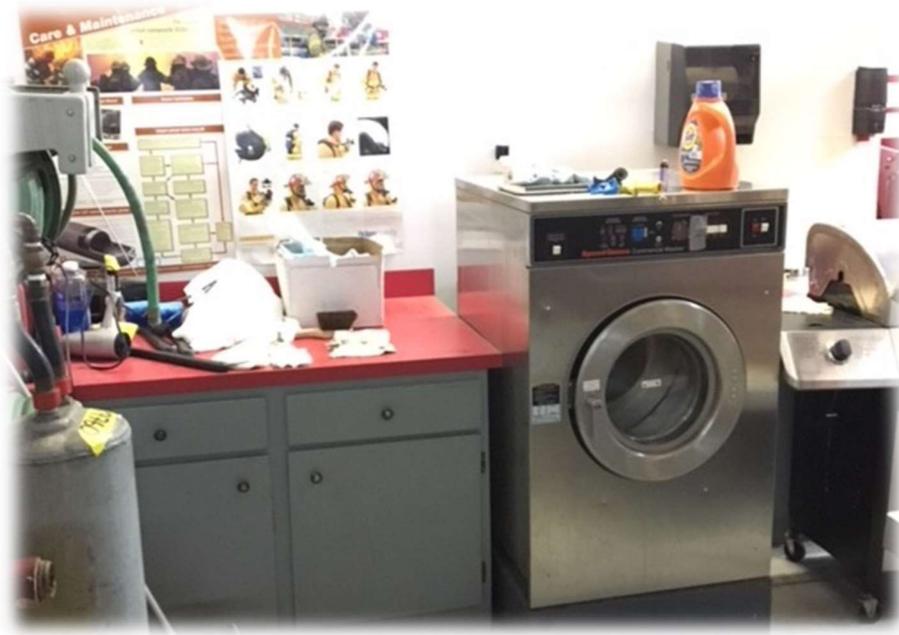
**04-06/18: Recommend reviewing of Turn-out-Gear (PPE) washing area.** The Fire Service has seen many changes, and decontamination of firefighter PPE has become another action in increasing life of PPE, and reducing the risk of cancer in firefighters. The PPE washing area is in the apparatus bay in close proximity to the SCBA fill station, and sink. This area may be used more often than the SCBA area with decontamination after ems emergencies, crashes, wildland fires, as well as structure fire and training.

- Chief Maetzold again stated during warmer weather apparatus can be placed outside when these tasks are completed, but during freezing temps this task becomes more difficult because of space.

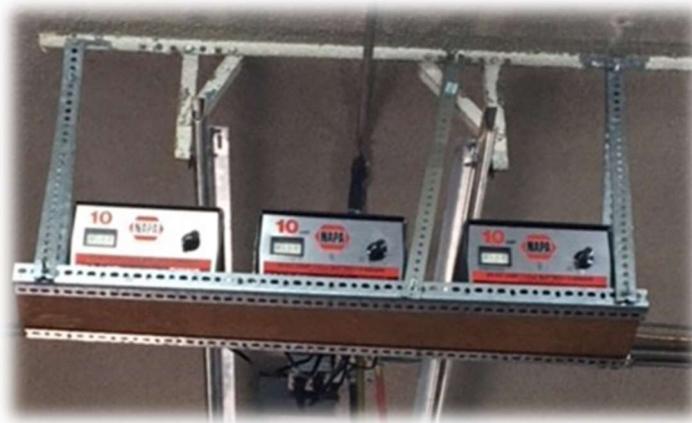
**05-06/18: Recommend reviewing the use of Battery Tenders and Electrical Hazards.** Battery tenders are commonly used for vehicles and equipment that have battery drawdown, and/or that do not get started often. These tenders help maintain the correct voltage to start and operate the apparatus. During the walkthrough the station currently has a couple of Batter Tender Banks mounted to the ceiling and hooked into the electrical system. These tender banks could pose a long-term concern with location, fall hazards, proximity to water, as well as a potential fire hazard.

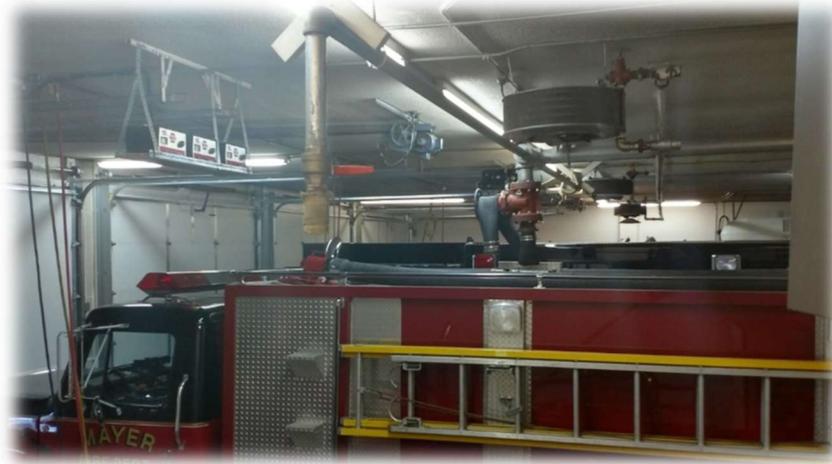
(Current Overhead Fill – Inside Station)

**06-06/18: Recommend reviewing the use of overhead fill stations for apparatus.** As the Fire Service has modernized and updated Fire Apparatus the overhead fill has been replaced with safer methods. When the firefighter needs to climb onto the top of the apparatus to fill with water, they increase the potential of falling. These chances greatly increase during an emergency, and especially during the winter months. If the apparatus is unable to fill from ground level, overhead may be the only option. As apparatus are replaced, adding ground level fill intakes will reduce and/or eliminate the need to climb on the apparatus. The current station does have a ground filling station located at the back of the building. This again does pose an issue maintaining a 4-foot clearance around apparatus. Encouraging the use of the ground fill location, is a best practice for safety.

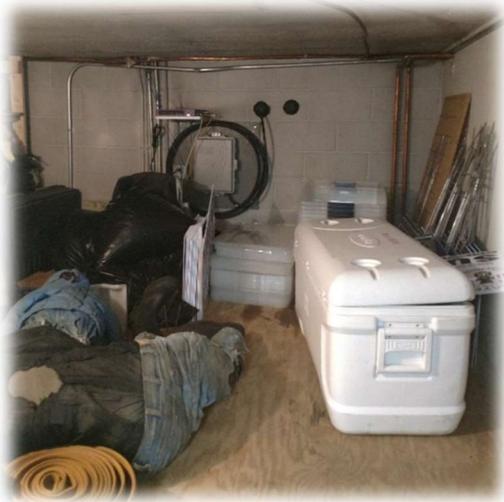
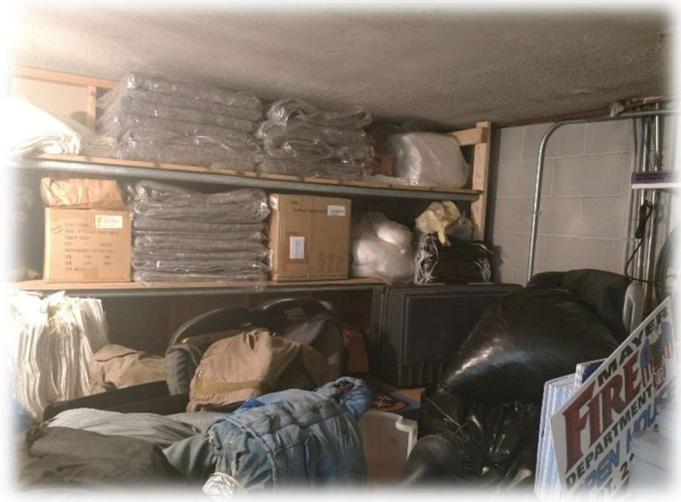
(Directly at top of stairs – directly above Chiefs office.)

- The storage area has shelves that are storing EMS equipment, training items, event supplies, as well as additional firefighter PPE.
- The second-floor storage areas have been kept organized, but the floor areas are starting to accumulate items with lack of additional storage room. The added storage items could be adding weight to the “dead load” of the floor construction and could potentially be problematic over time.
- The second-floor storage rooms also have low-ceiling height increasing the potential for injuries. When members need to access they will need to crawl or crouch. These actions could cause potential head injuries because of height, but could also create an awkward body posture when needing to move large or heavy items.

**07-06/18: Recommend reviewing storage areas above meeting office and meeting room.** The Fire Department have utilized the vertical storage areas about the office and meeting room for equipment storage, gear storage, and less used items. These areas include wall shelves, floor storage, and some HVAC equipment. This area is accessed via the apparatus bay using a staircase.

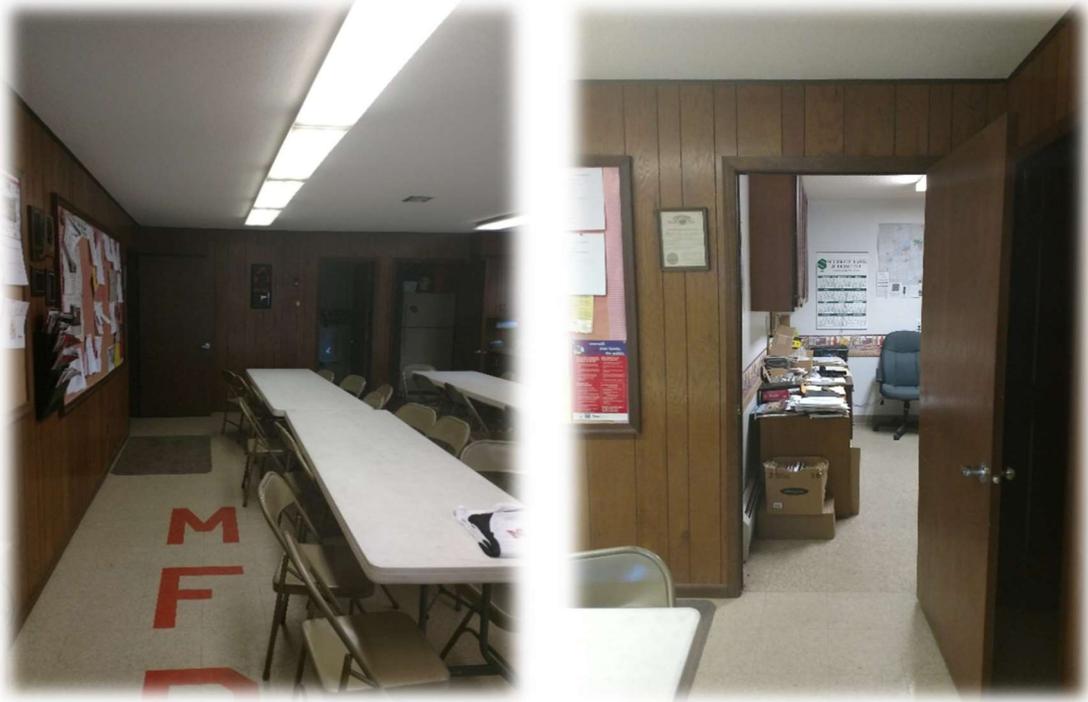
(Left Photo – Meeting Room with Tables & Chairs South  
Right Photo – Office off the Meeting Room)

- The current meeting room is 17.5' ft. x 34' ft. = 595sq ft. (minus the kitchenet 18sq ft.) = 577sq ft. The [Minnesota State Fire Code on Assembly Occupancies](#) , using tables & chairs is 15sq ft. per person. Using this method, the occupancy for this room is approximately 38 People.

- The meeting room, bathrooms, and office are directly connected to the apparatus bays. This is also a concern for exhaust and continued carcinogen exposure.

**08-06/18: Recommend reviewing the office, meeting room, and restrooms for occupancy load, access and ADA accessibility.** The meeting room and kitchenet are directly in the main front door, and is a location where meetings, trainings, and gatherings typically occur. At the rear-left of the meeting room is an office with two desks and file storage. The rear of the meeting room is both an Male & Female Restroom, as well as a utility/storage room.
