**CITY OF MAYER  
REGULAR CITY COUNCIL MEETING  
CITY COUNCIL CHAMBERS  
MONDAY, JULY 27, 2020  
6:30 PM**

MAYER CITY COUNCIL MEETING MINUTES – JULY 13, 2020

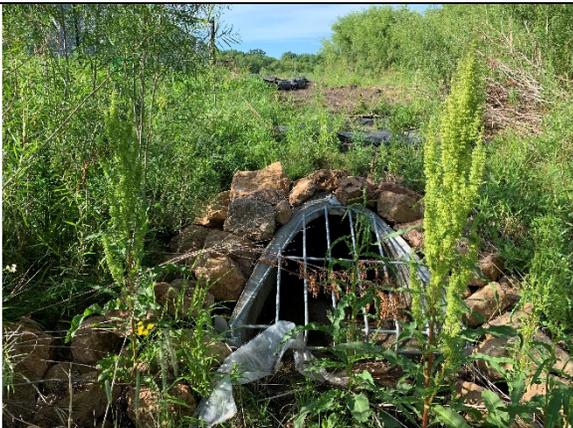
**South FES outfall to Pond**

Comments: Significant Willow growth on the west bank of the pond, scouring after riprap and sediment accumulation with vegetation growth in the south FES.  
Clear access to the two FES outfalls into the pond. Significant Willow grown obstructing access to pond outlet pipe directed to OCS structure.

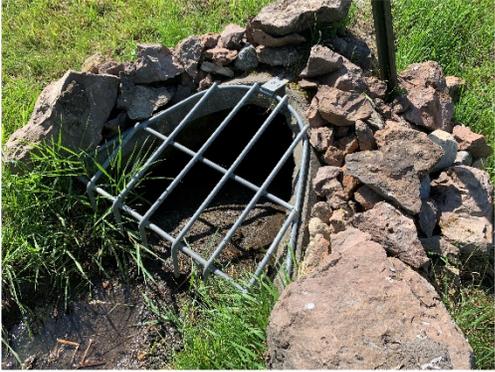
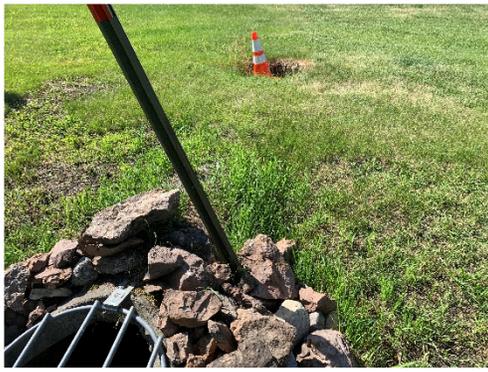
Comments: Minor vegetation around entire pond with heavier tree cover on east/SE banks. There is a hole to the south of the south FES outfall into the pond.  
Clear access to the FES outfall and the OCS structure.

<b>South FES outfall to pond.</b>	<b>Cone is placed in the hole directly behind south FES.</b>

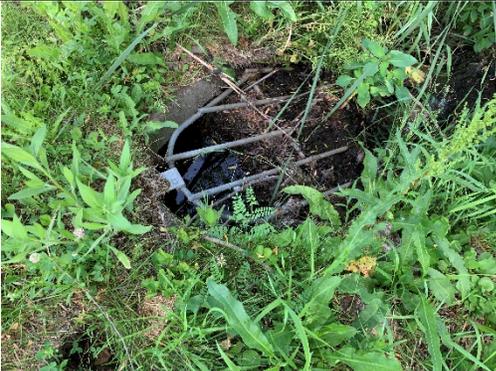
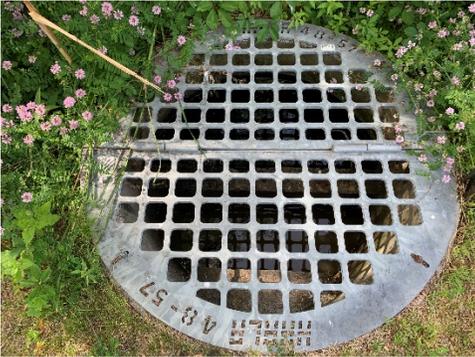
Comments: Vegetal growth around entire pond with large trees on the north/east banks. Lots of debris in south FES outfall to pond. Clear access to the FES on the south side and the OCS structure on the north side.

<b>South FES outfall to pond.</b>	<b>Pond OCS structure.</b>

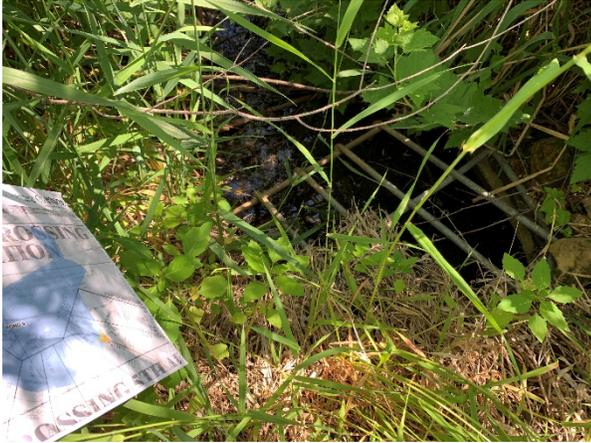
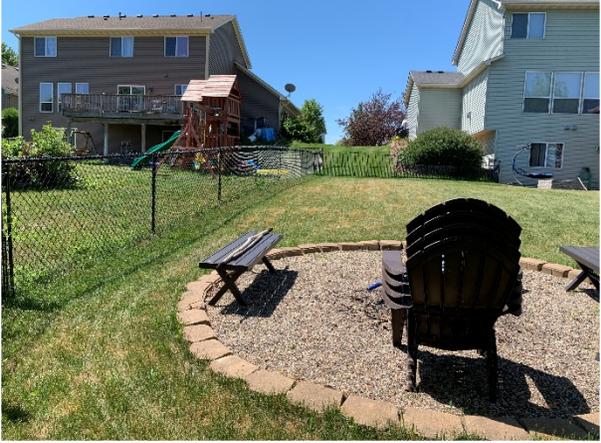
Comments: Significant vegetation around entire pond, lots of tall trees. Minor vegetation/debris in NW FES structure and trees growing next to SE FES structure.  
 Fence blocking access to NW FES structure and the outlet pipe directed to the FES structure. Trees growing next to SE FES structure.

<b>NW FES outfall to pond.</b>	<b>Fence that runs along piping that connects to NW FES.</b>

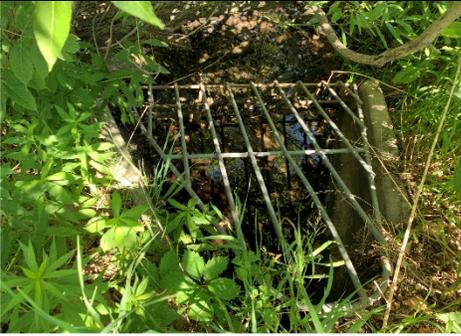
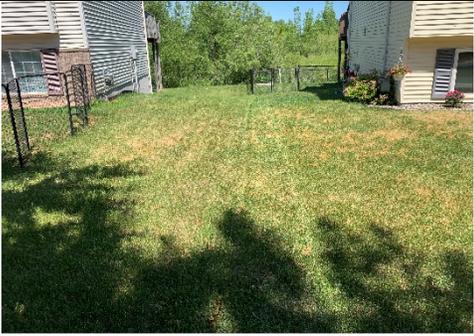
Comments: Minor sediment/debris in FES structures and trees growing on top and beside of SE FES outfall to pond.  
Fence along pipes directed to SW FES. Clear access to SE FES and OCS structure.

<b>SW FES outfall to pond.</b>	<b>Fence alongside pipes directed to SW FES.</b>

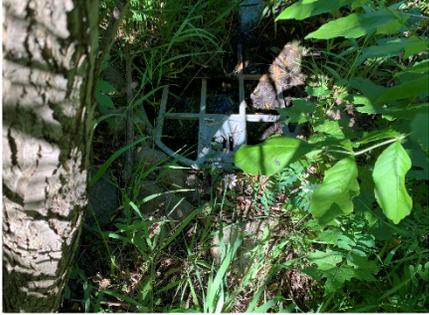
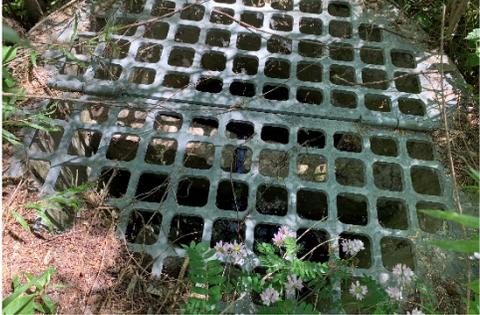
Comments: Significant tree growth around entire pond, sediment/debris/vegetation accumulation in NE FES.  
Access to NE FES has minor vegetation/trees. OCS structure surrounded by heavy vegetation.

<b>NE FES outfall to pond.</b>	<b>Pond OCS structure.</b>

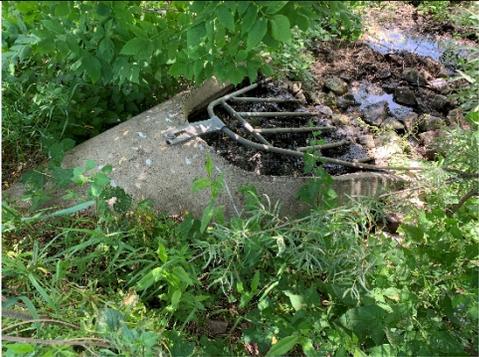
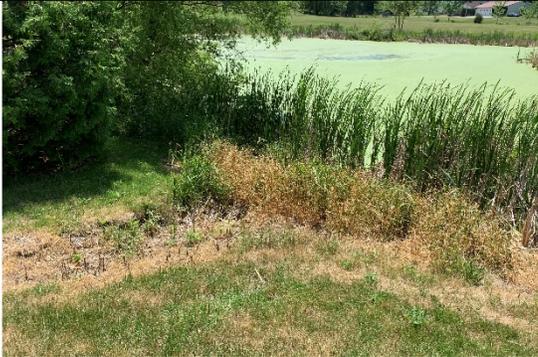
Comments: Significant tree growth on north & west banks of the pond, sediment accumulation in NE FES and dead vegetation covering west FES. Erosion around OCS structure.  
 Clear access to the OCS structure with trees/park built over pipe directed to OCS structure. Minor vegetation/trees around both FES.

<b>NE FES outfall to pond.</b>		<b>Erosion around OCS structure.</b>

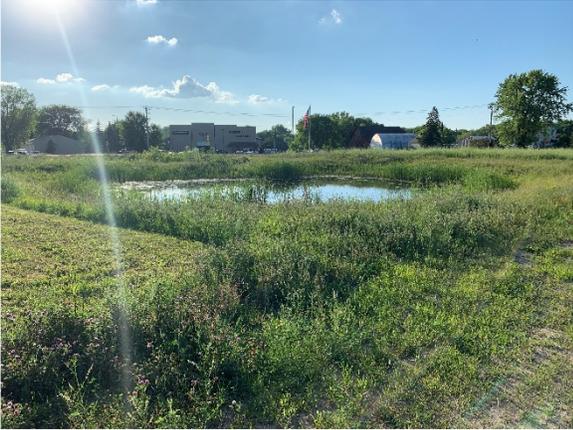
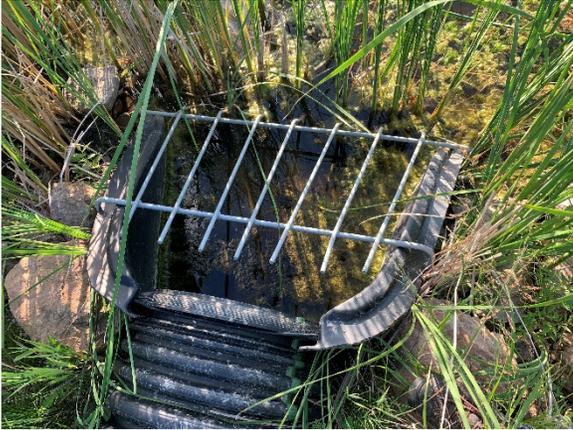
Comments: Vegetation around pond but no large trees. Pond FES inlet on east side has slight sediment buildup. In basin on west side of pond there is an area drain that does not have a cover on it.  
Clear access to all structures, just have to walk through taller grasses.

<b>Pond view taken from southeast side.</b>	<b>Pond inlet on east side.</b>

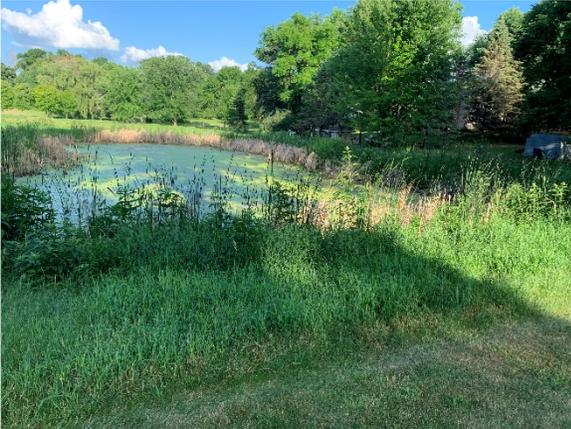
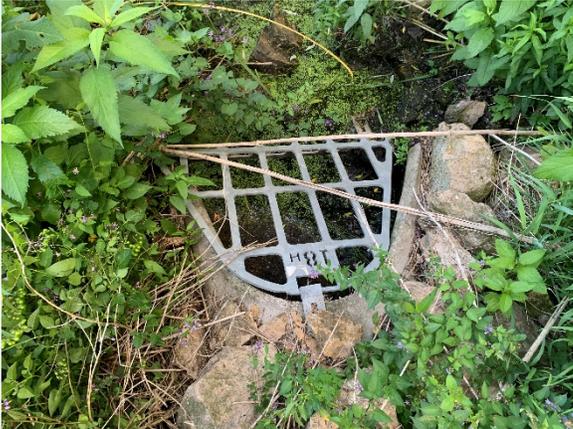
Comments: Trash guard broken on NW FES and debris in east FES with scour at the end of the pipe.  
Clear access to all three FES as well as the OCS structure.

<p style="text-align: center;"><b>Pond view taken from northwest side.</b></p>	<p style="text-align: center;"><b>Northwest pond inlet with broken trash guard.</b></p>

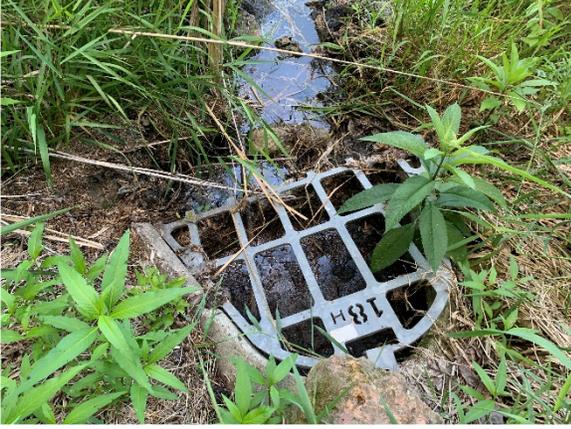
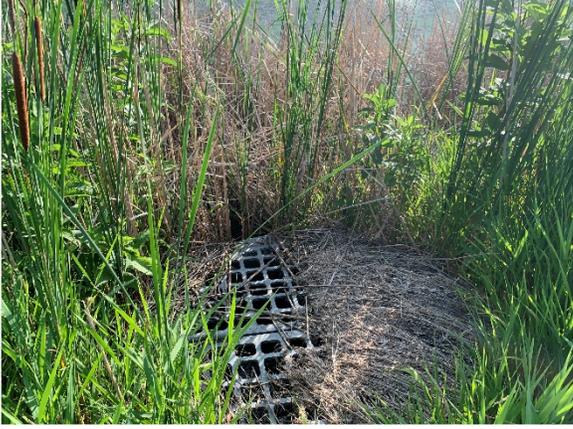
<p style="text-align: center;"><b>Southwest pond inlet.</b></p>	<p style="text-align: center;"><b>Pond skimmer on east side of pond.</b></p>

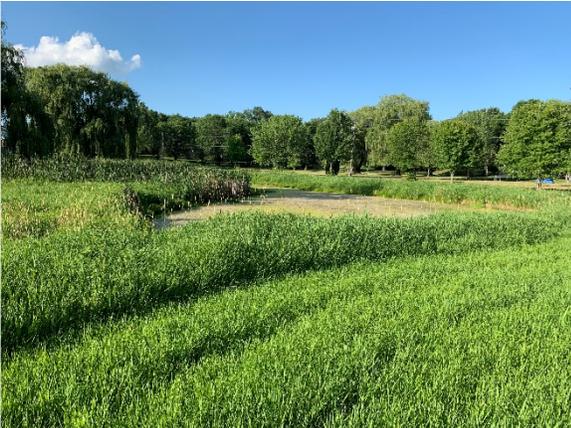
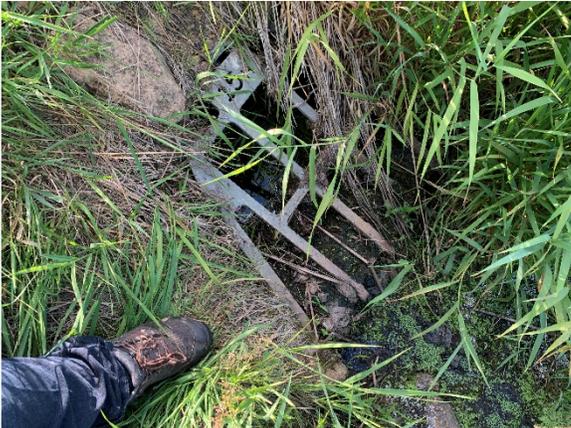
Comments: A few willows on NW bank. SE FES that flows the OCS structure has debris in FES and there is scour at the end of the pipe.  
The steel box culvert that connects ponds 20 and 21 is in very poor condition.  
Clear access to all FES, the OCS structure and the steel box culvert.

<p style="text-align: center;"><b>Pond view taken from southwest side.</b></p>	<p style="text-align: center;"><b>Inlet on southwest side, from Pond 19.</b></p>

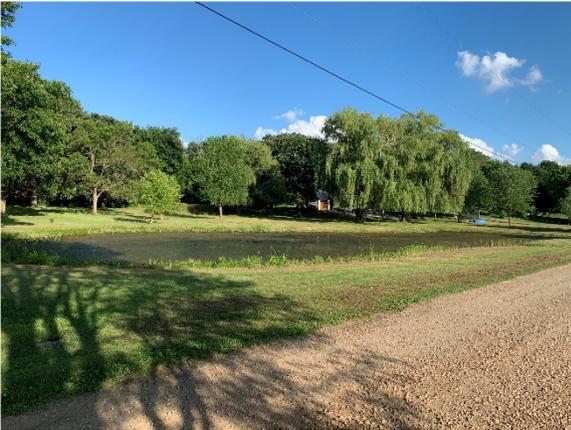
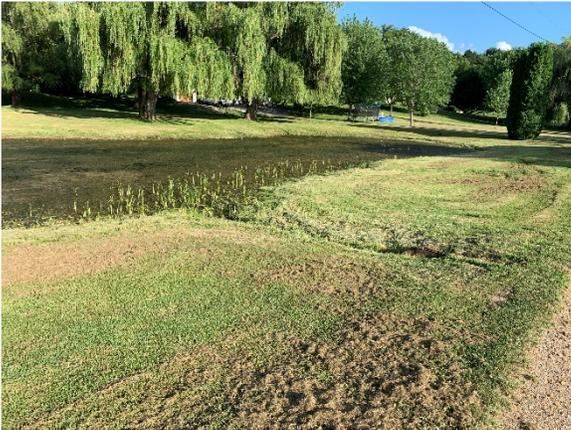
Comments: No trees/vegetation surrounding pond. No outfall FES to pond found. There is a culvert that goes under the road and connects to Pond 20.  
 Clear access to culvert.

<p style="text-align: center;"><b>Pond view taken from northwest side.</b></p>	<p style="text-align: center;"><b>Location of square metal culvert to Pond 20.</b></p>

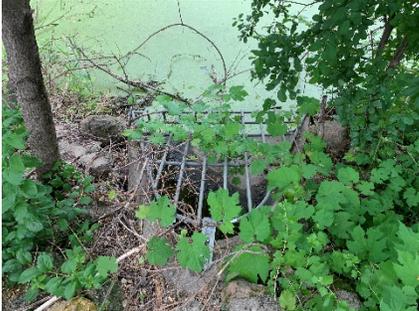
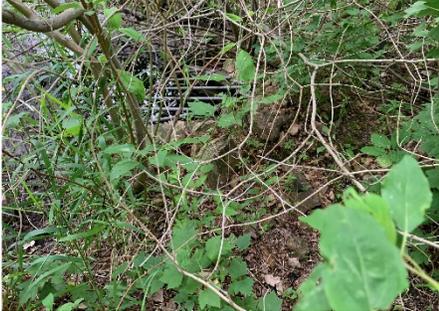
Comments: Significant tree/vegetation growth around entirety of pond. Possible scour at SW FES and the northern FES are covered by trees/shrubs but the structures themselves are clean.  
 SW FES is easily accessible from Hidden Creek Blvd. To access northern FES & OCS structure you must climb through woods and go into the field.

<b>SW FES outfall to pond.</b>		<b>NW FES connected to OCS.</b>

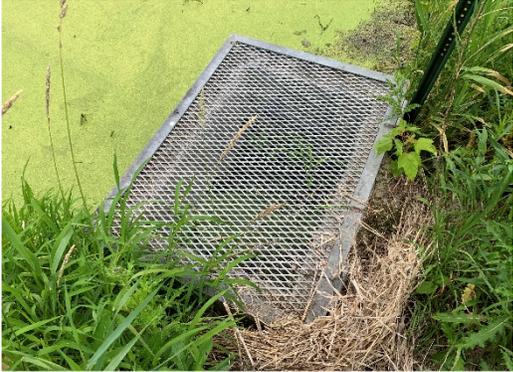
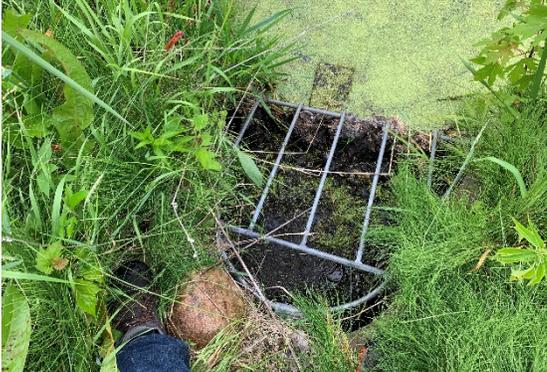
Comments: Significant tree cover on north & east banks. Large stick/debris pile on west side of the pond. Vegetation growing inside FES and significant debris/sediment growing inside SE FES.  
Clear access to all FES. Trees lay over the piping that connects the SE FES to the catch basin.

<b>Pond OCS structure.</b>	<b>SE FES outfall to pond.</b>

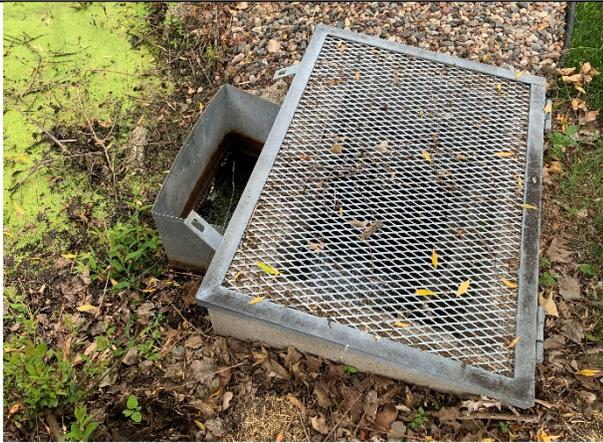
**Pond box OCS structure.**

Comments: Large trees surrounding pond on most sides. Significant debris/organic materials in the south FES. Debris in the east FES. Box OCS structure is clogged and there is a board in the catch basin that connects to the OCS structure. All FES and the OCS structure are easily accessible.

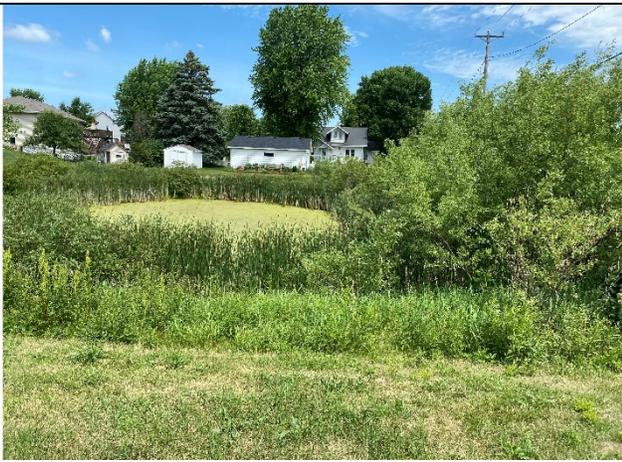
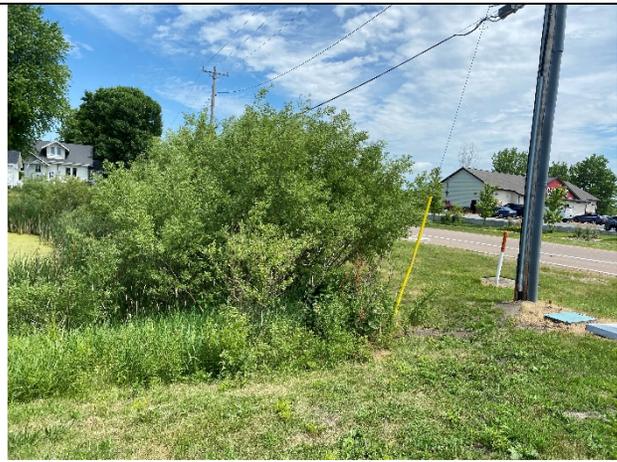
Comments: Trees growing on SE bank of pond. South FES full of sediment & vegetation growing inside and around structure. South FES surrounded by tall grasses but still accessible. Not able to find storm MH because significant amount of vegetation/tall grasses on east bank.

<b>View of pond from south end, directly behind south FES.</b>	<b>Heavy vegetation around SE corner of pond.</b>

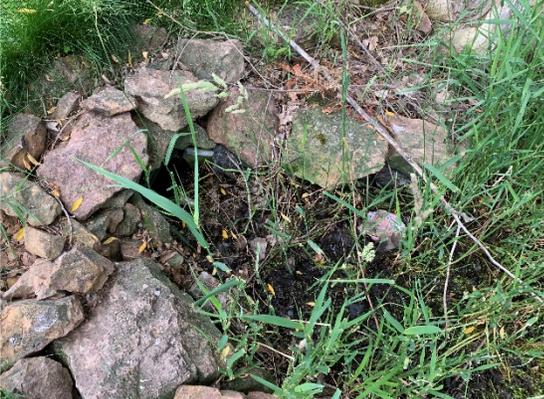
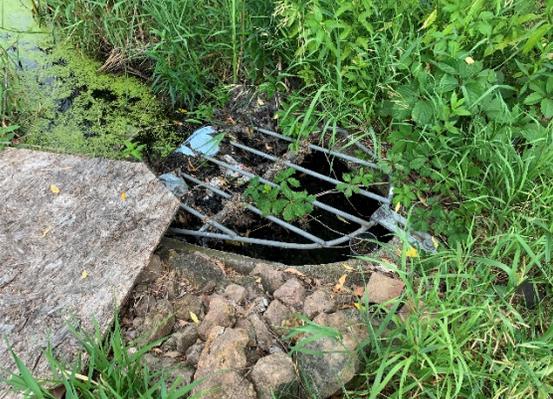
Comments: Tree/vegetal growth around entire pond. Debris in both the FES on east side. Minor debris covering outlet on SW corner.  
 Fence runs along piping that is directed to east FES.  
 All FES are accessible with minor vegetation surrounding structures.

<p style="text-align: center;"><b>East FES outfall to pond with piping coming from the east.</b></p>	<p style="text-align: center;"><b>East FES outfall to pond with piping coming from the north.</b></p>

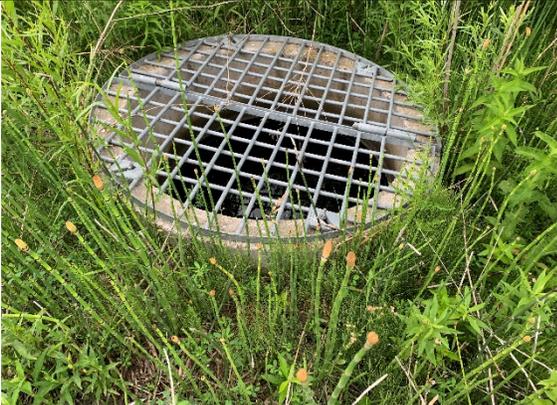
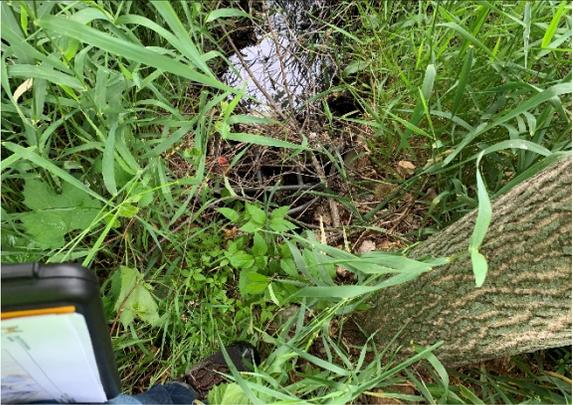
Comments: Tree/vegetal growth around entire pond. Could not find NW FES due to vegetation cover. SW FES has significant debris in structure and a tree growing over structure. Corner of a wooden fence over pipe that is directed to SW FES.  
Clear access to the OCS structure and SW FES, minimal vegetal growth. Not able to find/access NW FES due to vegetal growth.

<b>Pond OCS structure.</b>	<b>SW FES outfall to pond.</b>

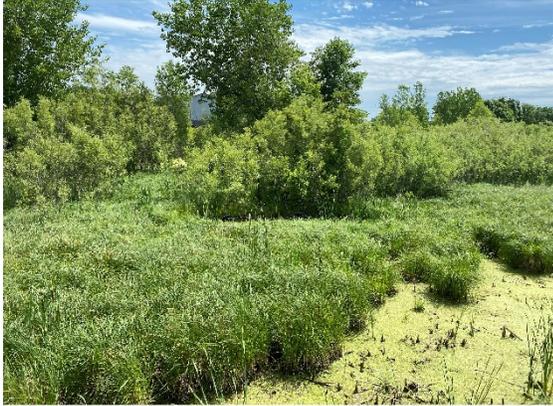
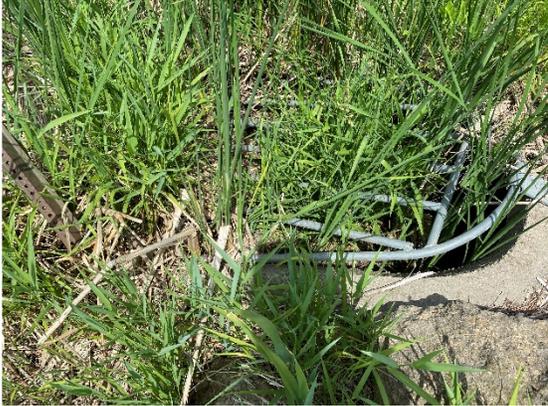
Comments: Significant tree/vegetation growth around entire pond. East FES has significant debris and vegetation in structure.  
Wetland/marsh area on west side of pond between the water and Ash Ave S.  
East FES is accessible but the two FES on the NW corner were not accessible because of water/marsh area.

<b>Two NW FES are in the taller grasses across this water area.</b>	<b>East FES outfall to pond.</b>
