**Re: Fire Department Building Safety Walkthrough Conducted on June 4, 2018**

### **The City of Mayer Fire Department: 400 Ash Ave N. Mayer, MN 55360**

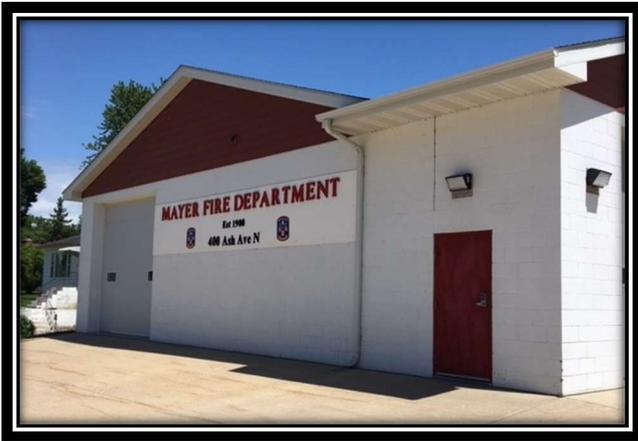
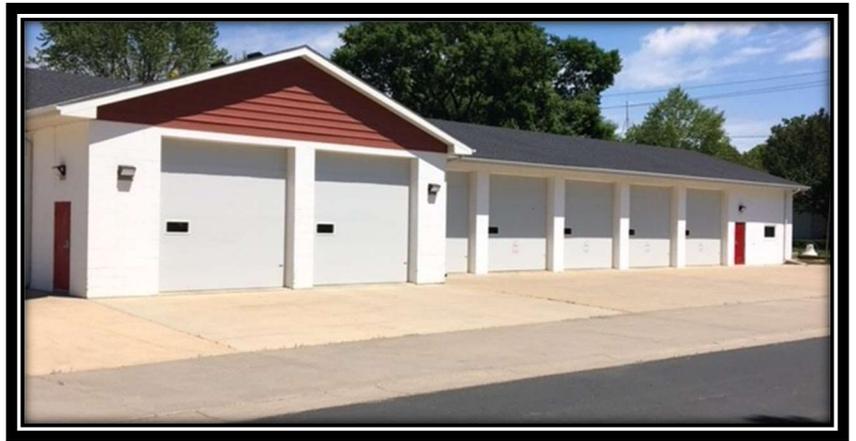
**01-06/18: Recommend reviewing apparatus bays for access and clearance.** The Mayer Fire Department has a very well kept and organized facility including their apparatus bays. All bays have been filled with apparatus, as well as gear lockers, maintenance equipment, and some fire equipment storage.

- Apparatus floor markings help ensure proper location of apparatus to maximize access, and limit hazards. Even with these parking markings, there is limited access at the front and rear of most apparatus for members to walk around apparatus. According to the [Safety and Health Considerations for the Design of Fire and EMS Stations](#) published by the US Fire Administration: Page 67 – A minimum 4-foot clearance shall be maintained (designated) around apparatus parked within the station. Most of the current apparatus do have a 4-foot clearance between. The Front & Rear of almost all apparatus does not meet a 4-foot clearance, with a few less than 2-feet.
